ARCHEOLOGICAL INVESTIGATIONS
OF THE ELKHORN RANCH SITE

Dee C. Taylor
Montana State University

(1959)

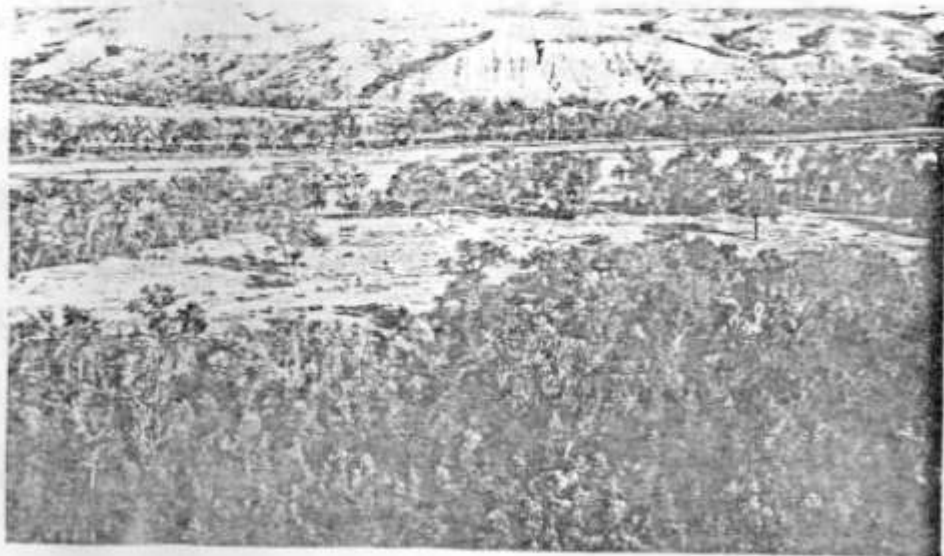
Figure 1.

A view of the Elkhorn Ranch clearing looking towards the east. A very careful scrutiny will reveal our excavation of the house and barn. The base line runs between the cottonwood trees in the middle of the clearing.

The south side of the house is shown in Figures 1 and 19, and it also appears in Roosevelt's rough plans. There were two windows and a door at ground level on this side and another window higher up in the gable. The door opened from a hall out onto the southern piazza. This latter structure was 8 or 9 feet wide and about 14 feet long. It was covered by an overhanging shingled roof which sloped down away from the house and was supported by posts at each corner.

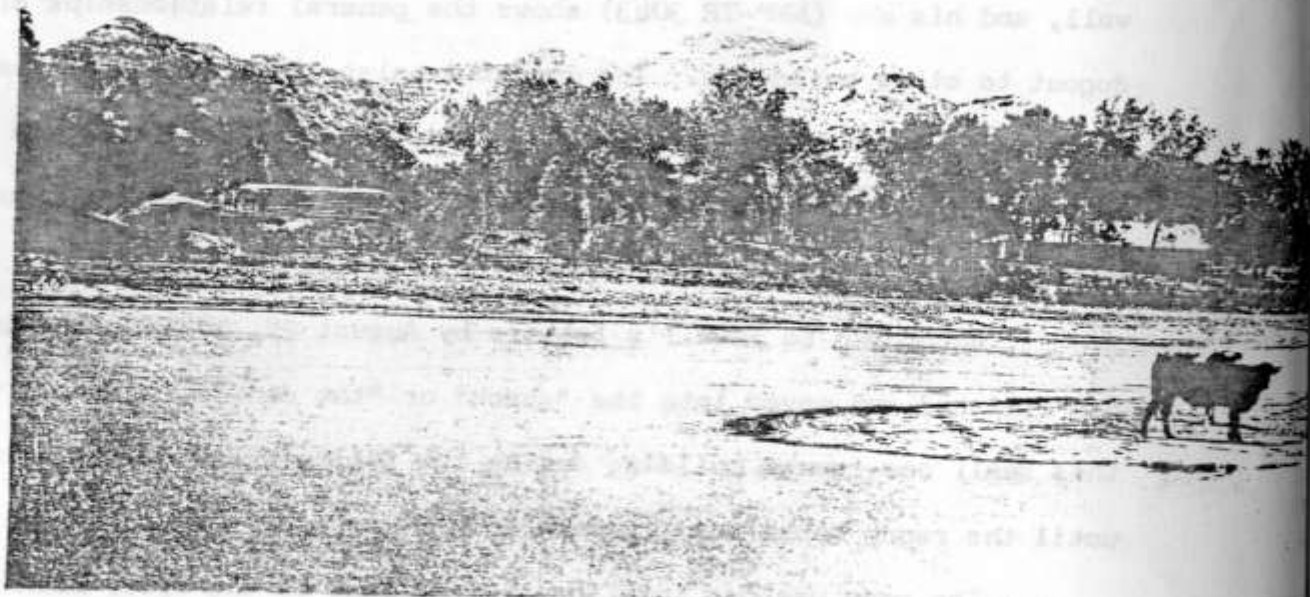
Figure 2.
Theodore Roosevelt's picture of the Elkhorn Ranch. Dugout and blacksmith shop appear on the left, the ranch house on the right.

We know nothing of the floor or interior furnishings. Undoubtedly there was a stove for heating and cooking, but it is not possible to see a chimney in the photograph. During his excavations Beaubien noted that the wall posts were rotted below the floor level but were charred and burned above.

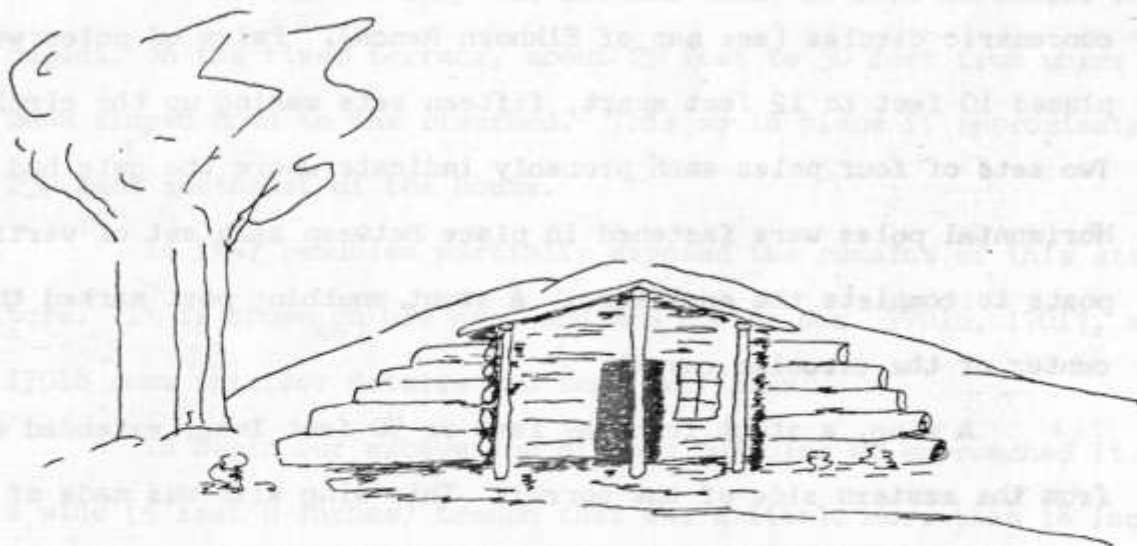
Figure 3.
Sketch of Dugout.

wall and the entryway were on the east facing the Little Missouri River. In his 1957 excavations Beaubien found the inside dimensions of the room to be 12 feet (north-south axis) by 14 feet (east-west). The walls were made of juniper or cottonwood logs. Timbers, that appear to have been between 8 inches and 1 foot in diameter, were set upright in the ground, one log flush against the next, to form the walls. One might conjecture that the inside surfaces of the walls were whitewashed with lime.

The entry doorway was 2 feet 6 inches wide and was set almost in the middle of the east wall (the distance from the inside northeast corner of the dugout to the door's edge was 4 feet 10 inches). It is impossible to say whether or not there were windows in the east wall; it seems likely that there were some to let in light.

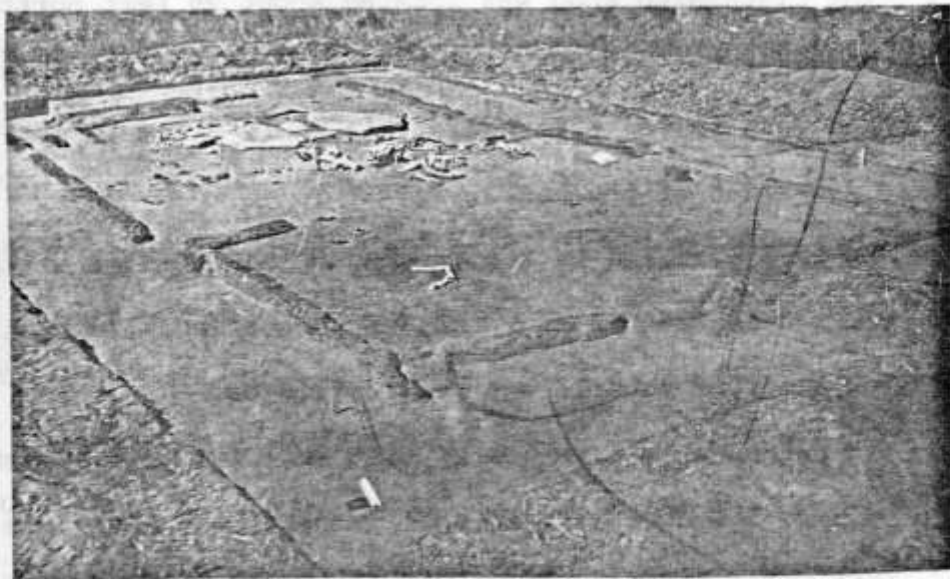
Figure 4.
View of the blacksmith shop from the south. Note fragment of partition log. South room in foreground. We think that the break in the south wall is from 1957 excavations. The unexcavated block on the right foreground was left to tie our excavations in with the surrounding area.

The outlines of this building are shown in our map of the blacksmith shop and in Figures 4, 5, and 6.

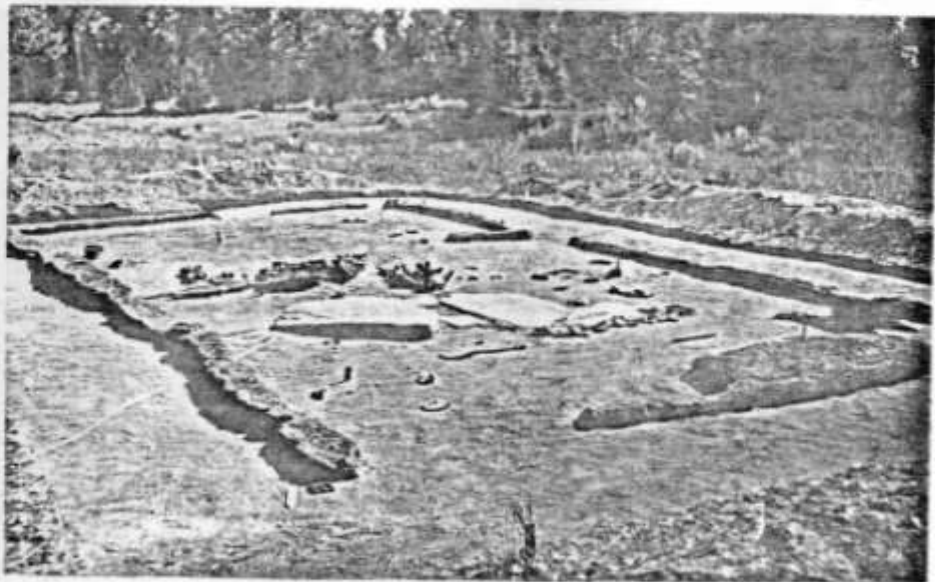
Figure 5.
View of the blacksmith shop from the north. The north entryway, bin, and forge stones are easily visible. Note cow skeleton.

I have shown a window in the northern wall because it seemed reasonable that one should be there. There is no archeological evidence of its presence. The foundation log was not intact in the northeast corner of the north wall (Figure 5). This area was partly disturbed by the 1957 excavations, but Beaubien mentions that he had to estimate where the walls had been. Likely the wall was not present then. It may be that there was a wide ($3\frac{1}{2}$ feet) door through the north wall where animals could be led in or out of the shop.

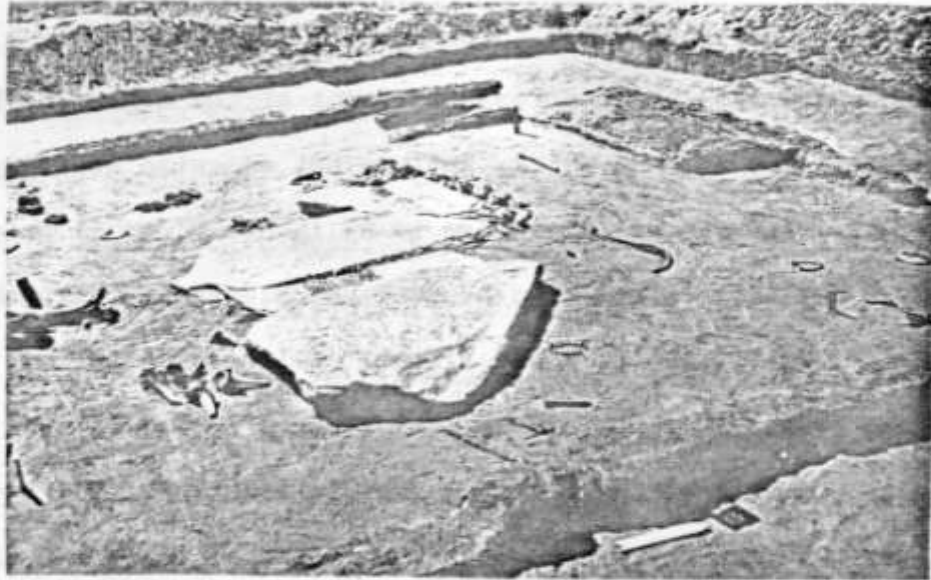
Figure 6.
View of the blacksmith shop from the east showing the forge stones, the bin; artifacts, bones and bricks on floor.

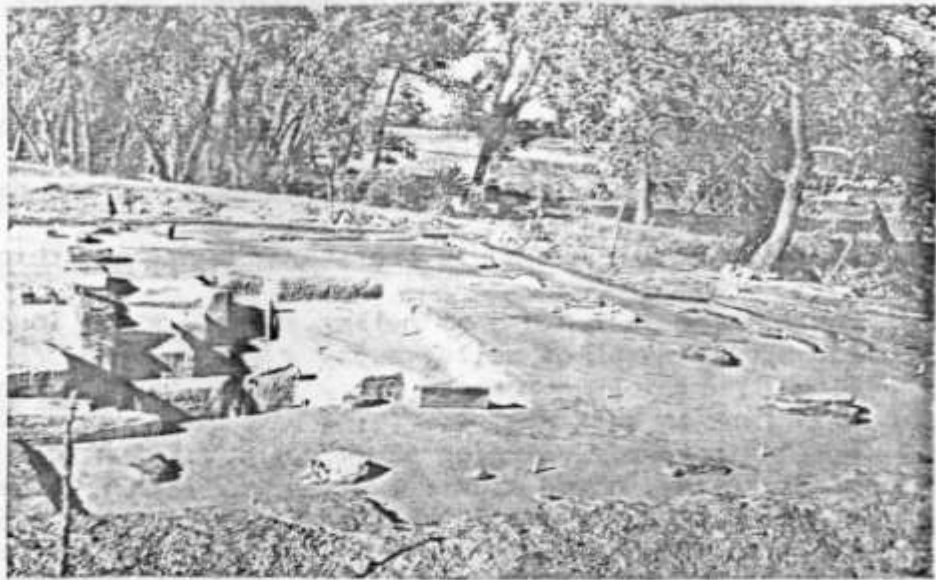
Figure 8.
Overall view of ranch house looking north. Note foundation stones and pieces of logs.

and an elk antler. Figure 8 shows the house after excavation.

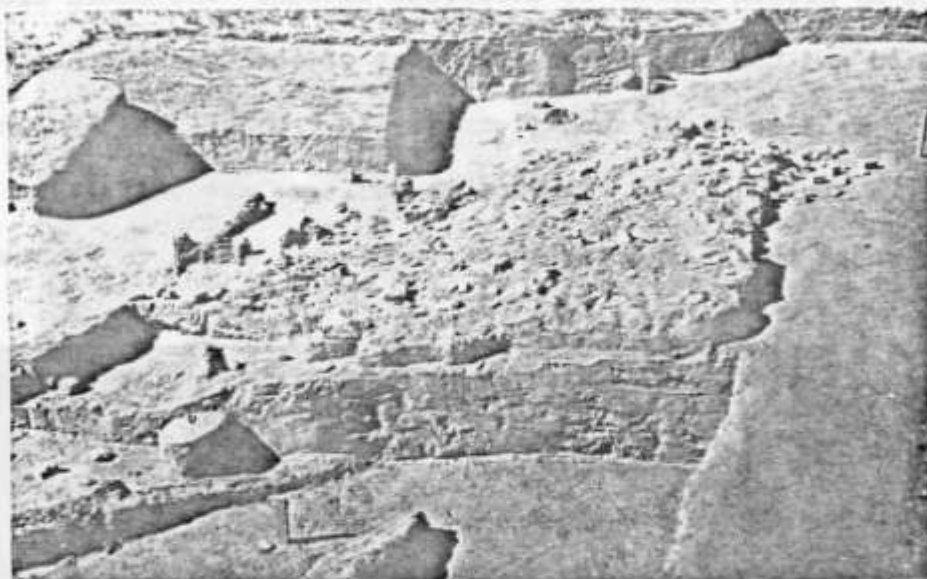
Figure 9.
View, looking towards the north, of the brick and mortar rubble from the chimney. Part of this material has been cut away in the foreground.

Part of the debris is shown in Figure 9, and it appears on the top overlay on our map of the house area. The brick and mortar undoubtedly was from a chimney or fireplace.

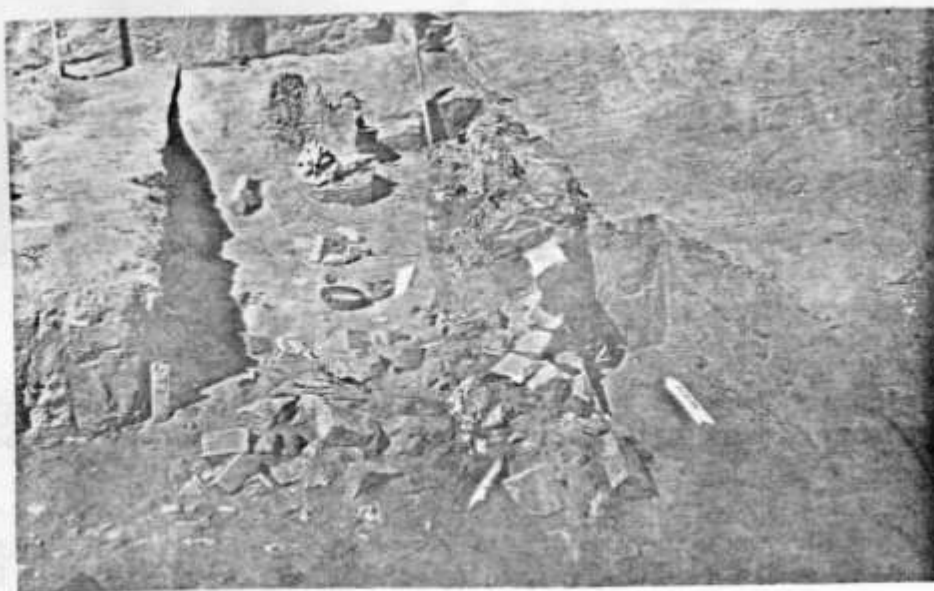
Figure 10.

We also found such items as tin cans, nails, a mountain sheep skull, a coyote skull. Many of these items are visible in Figure 10 which shows the passageway shortly after we began to remove fill.

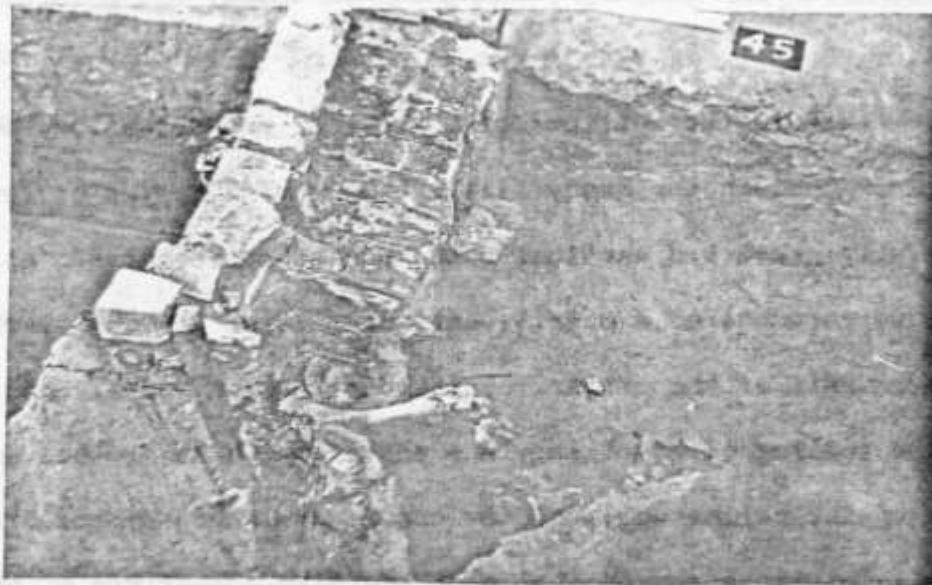
was in the flue. Perhaps this was a clean-out at the bottom of the chimney. The four layers of brick and mortar which would have been at the base, i.e., probably resting on the ground, were covered with red pigments. This feature is shown in Figure 11.

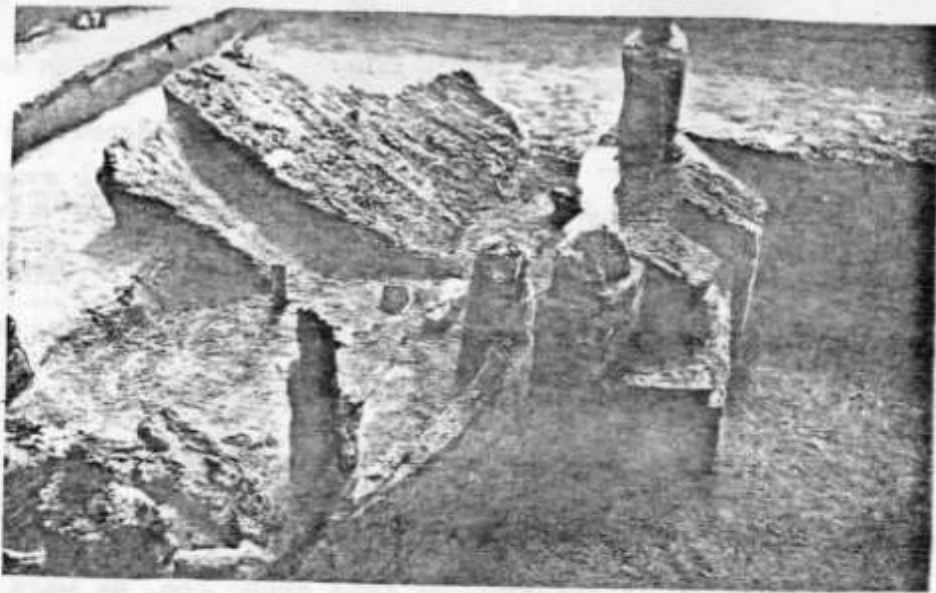
Figure 12.
Looking into the cellar during excavation, facing south. View to show levels of wood in darkroom.

Within the outlines of the cellar and passageway we worked our way down through the sandy fill by means of a series of levels. We carefully preserved vertical posts and other features. As we were doing this we encountered a nearly continuous layer of wood overlying the eastern half of the cellar. This wood, broken and slumped, appeared to be the remains of a ceiling, one end of which had rested on the eastern edge of the cellar wall and the other end on top of the dividing partition. This is shown on the second overlay on our map of the house. Another lower level of boards extended across the southern end of the narrow room. This may have been a workbench. (see Figure 12)

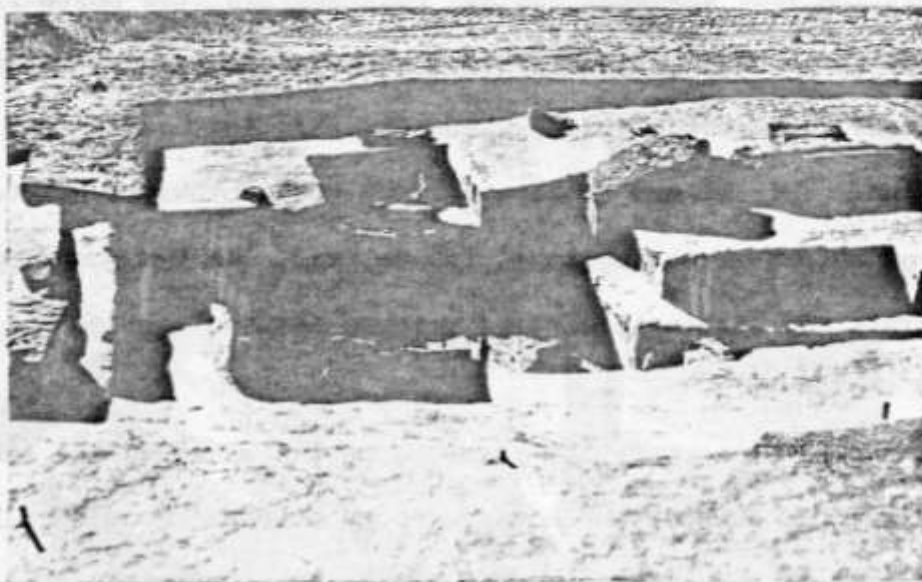
Figure 13.

caused from a barrel or crock that rested on the stone. This is shown in Figures 13 and 15. The remaining part of the floor in the west room was of earth. This part of the cellar must have had cupboards, shelving, and bins for storage.

wooden flooring (1 inch by 6 inches boards nailed to three cross beams) lay at the foot of the steps and covered most of the cellar area. The flooring measured 7 feet 6 inches by 5 feet 5 inches and once was painted white. When we took up this floor we recovered an 1883 Indian-head penny under it. The northern wall inside this room was made of boards. These were nailed vertically to the end of the flooring. One side of this wall fit flush against the partition, the other fit into a slot cut into the clay on the west. The eastern wall was the partition; horizontal boards had been nailed to the posts on this side. Where the ends of the boards came together on the uprights, narrow strips of wood had been nailed, apparently to make a light-proof seam.

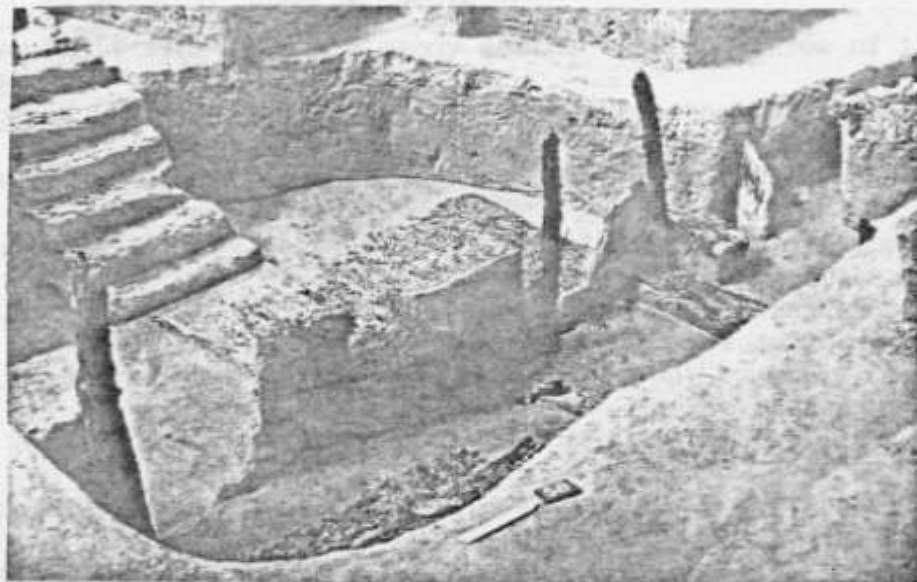
Figure 14.

Across the cellar looking northwest. This view shows the flooring, steps, partition, part of entry detail into the darkroom. Collapsed chimney shows in upper right corner.

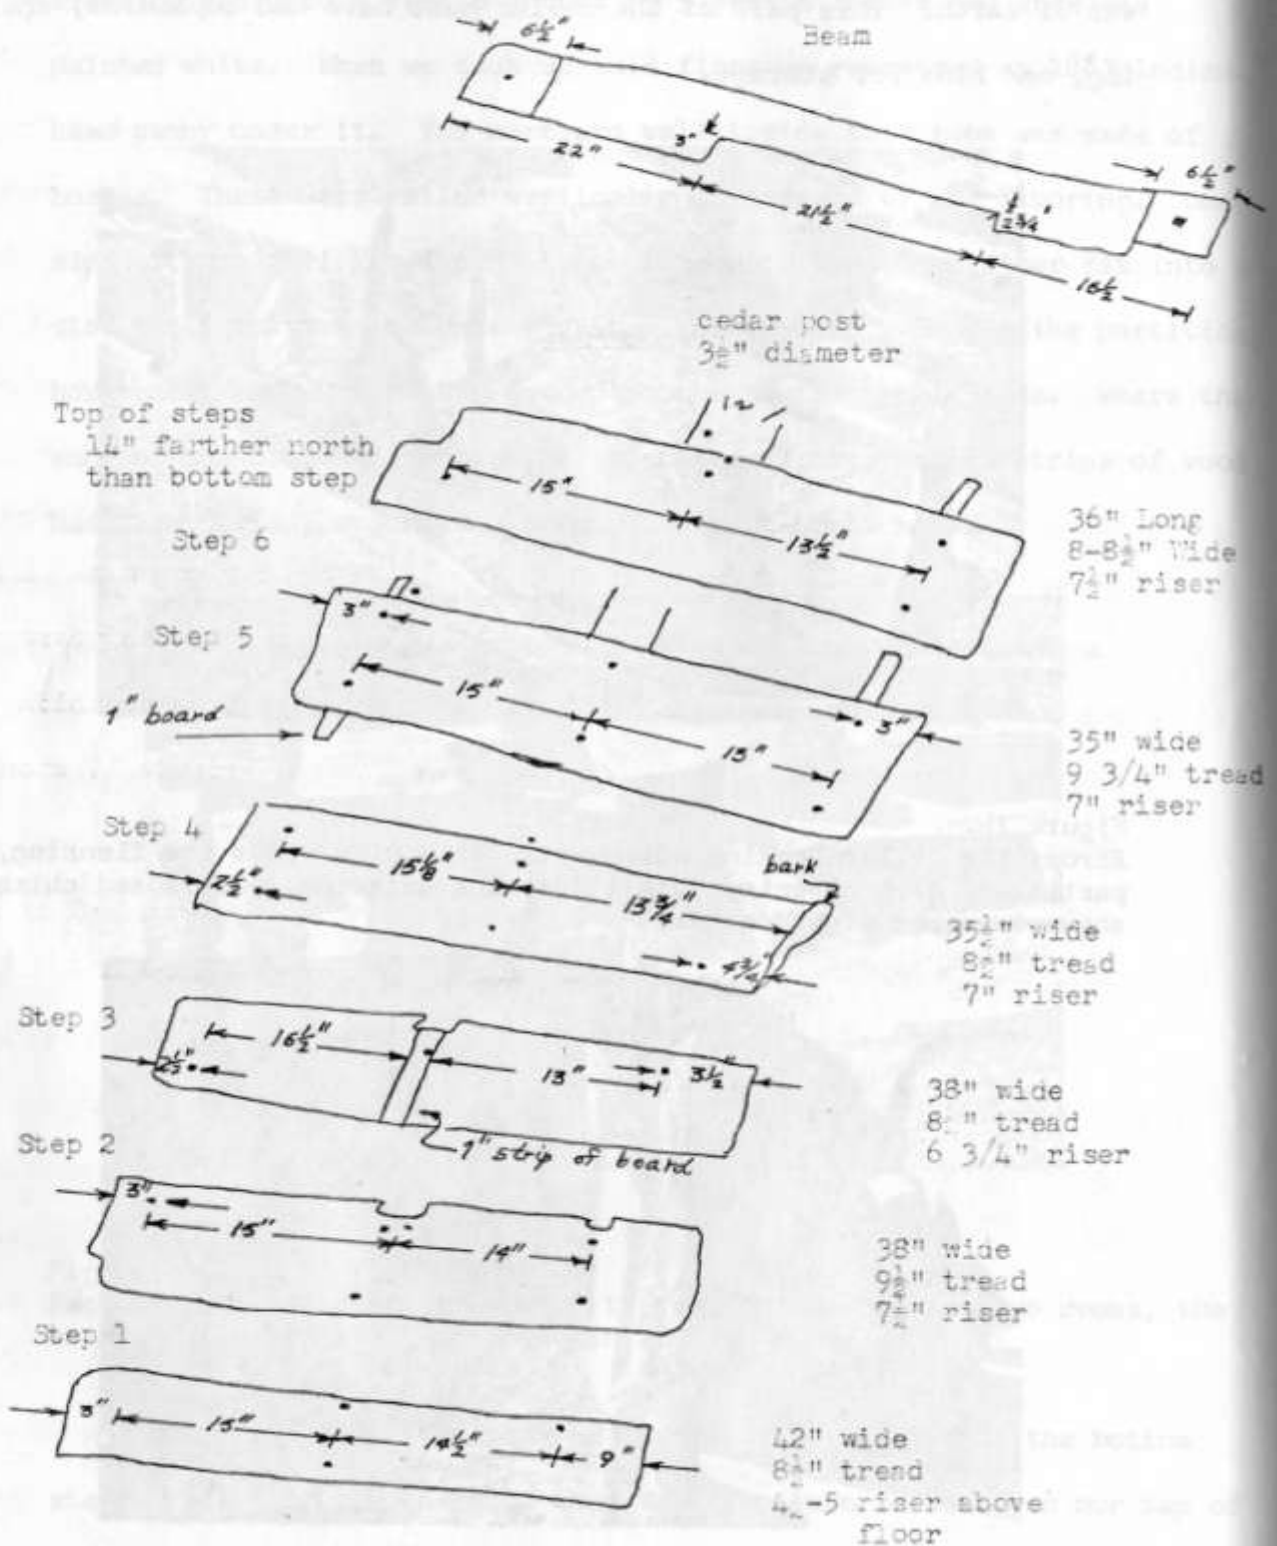
Details of the entry steps into the west cellar room are summarized in Figure 16.

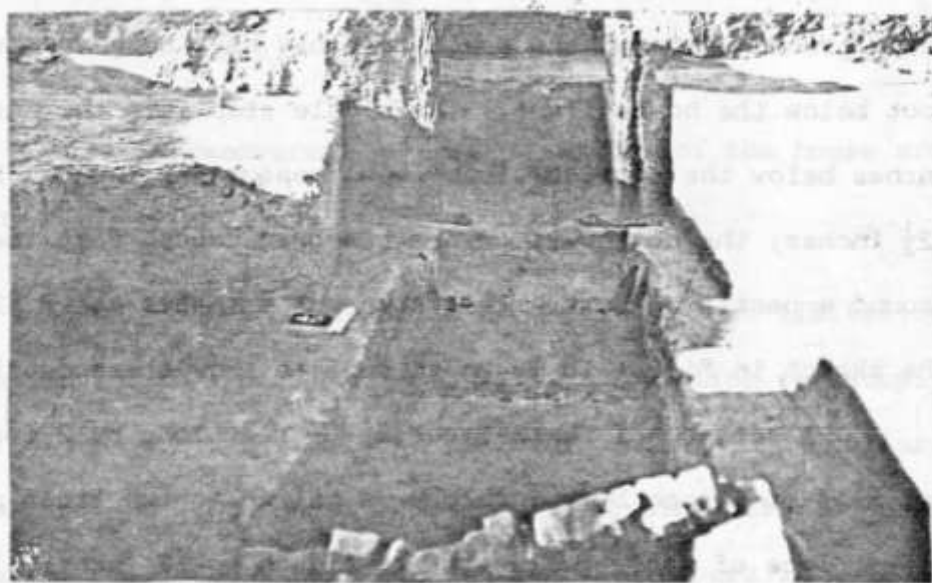
Figure 17.
Camera facing north. A view of the entry into the darkroom during excavation. Vertical posts were from the ladder. Note remains of vertical boards on side and step. Bricks in immediate foreground are part of collapsed chimney.

The darkroom was entered from inside the house, probably through a trapdoor in the kitchen floor. The descent was down a permanently-placed ladder. Vertical posts from this ladder still had fragments of cross pieces and nails intact, and we could easily see where others had been. The base of the ladder was set on a board, presumably so the butt ends wouldn't sink into the sandy earth. At the bottom of the ladder a passageway (2 feet 6 inches wide) led towards the darkroom. Two vertical boards set against the sides may be from a door frame (we found a piece of wood with a hinge on it in the fill) that closed off the passageway a little more than two feet from the ladder. Immediately beyond the door (if there was one) the corridor opened out to 3 feet in width, and about 2 feet 6 inches farther on there was a single step down. A board (1 inch by 12 inches) had been laid across the floor of the passageway. Possibly the board was to keep the edge of the step from crumbling as it would have done if it were only on sandy earth. Figure 17 shows this entryway.

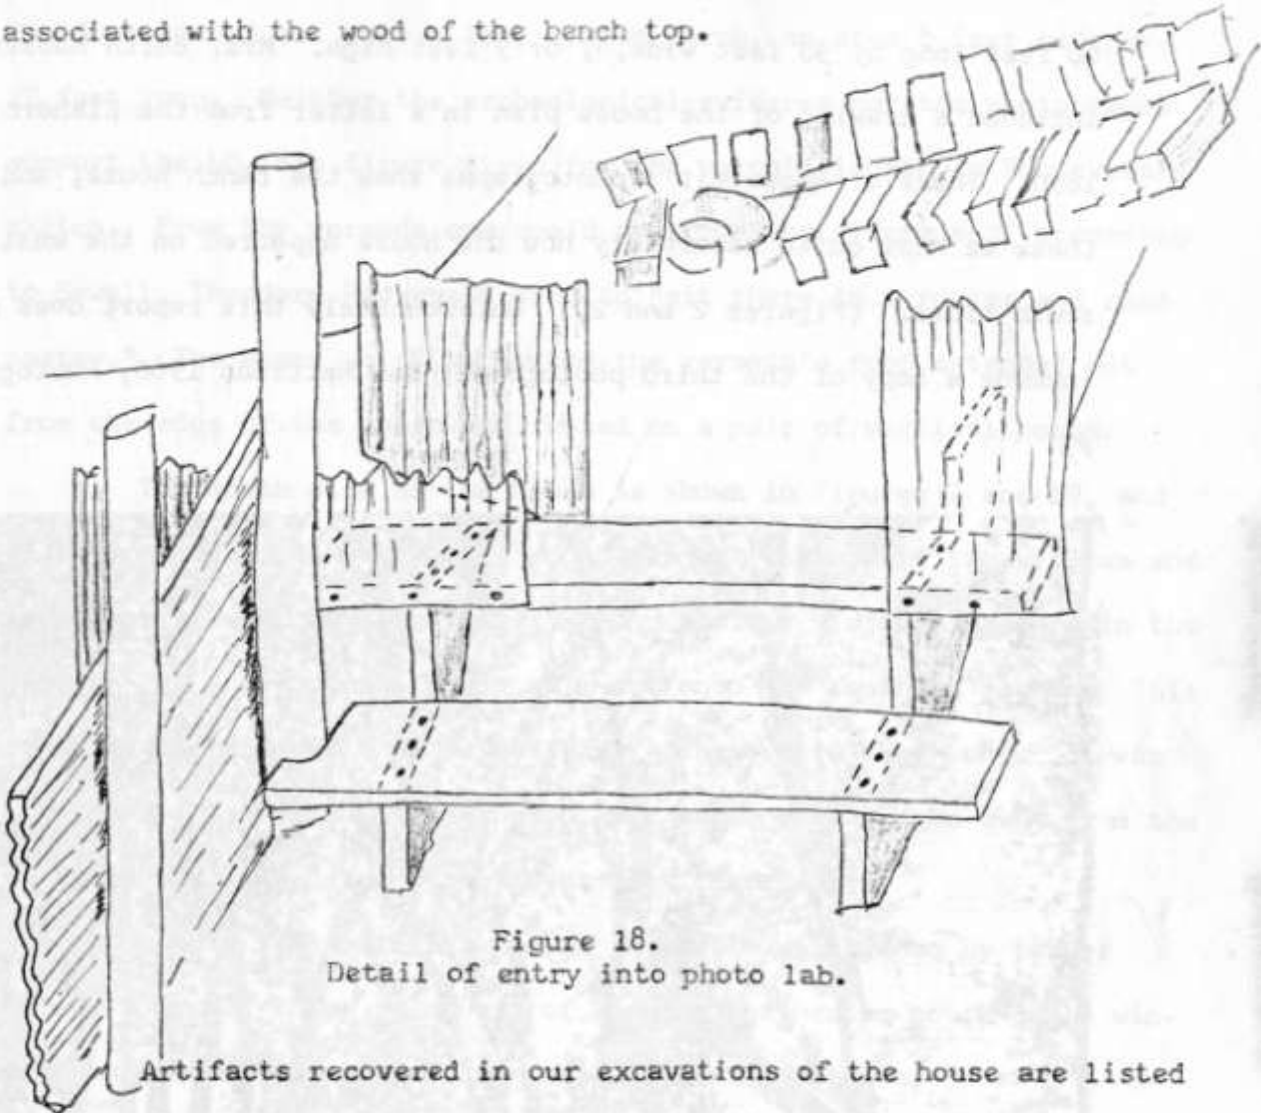
Figure 18.
Detail of entry into photo lab.

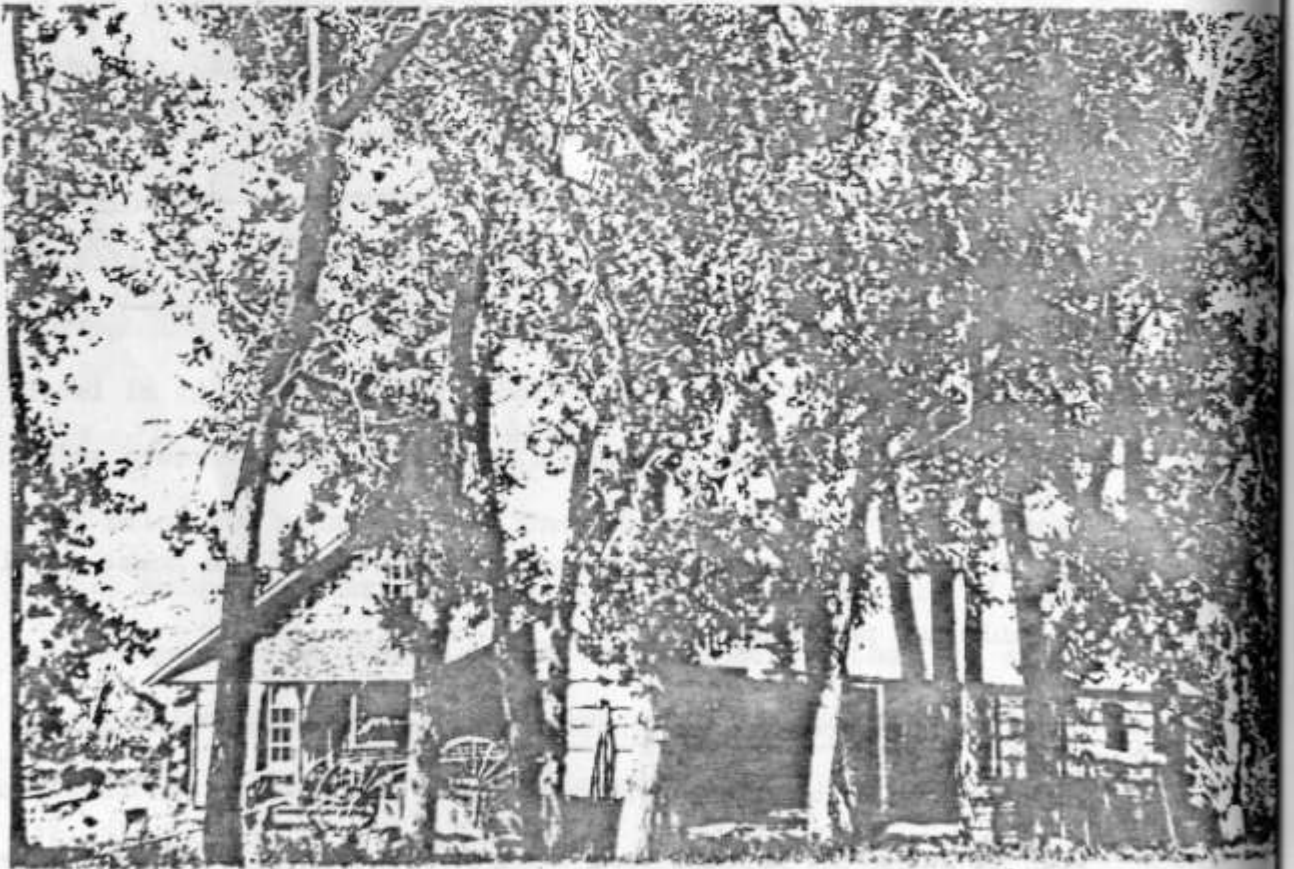
Figure 19.

A photograph taken by Theodore Roosevelt of the Elkhorn ranch house, later than 1885, possibly in 1892.

I suspect that there was a span of several years between some of the pictures of the ranch house. Roosevelt's overall view of the ranch (Figure 2) shows quite clearly fences intact around the house, and we found most of the posts in that fence. However, in another photograph (Figure 19) the fences have disappeared. I would agree with Mattison (1960, 16) that the first probably dates from ca. 1885 or 1886, but things look pretty decrepit in the second picture. I suggest this may have been taken even as late as during Roosevelt's 1892 visit.

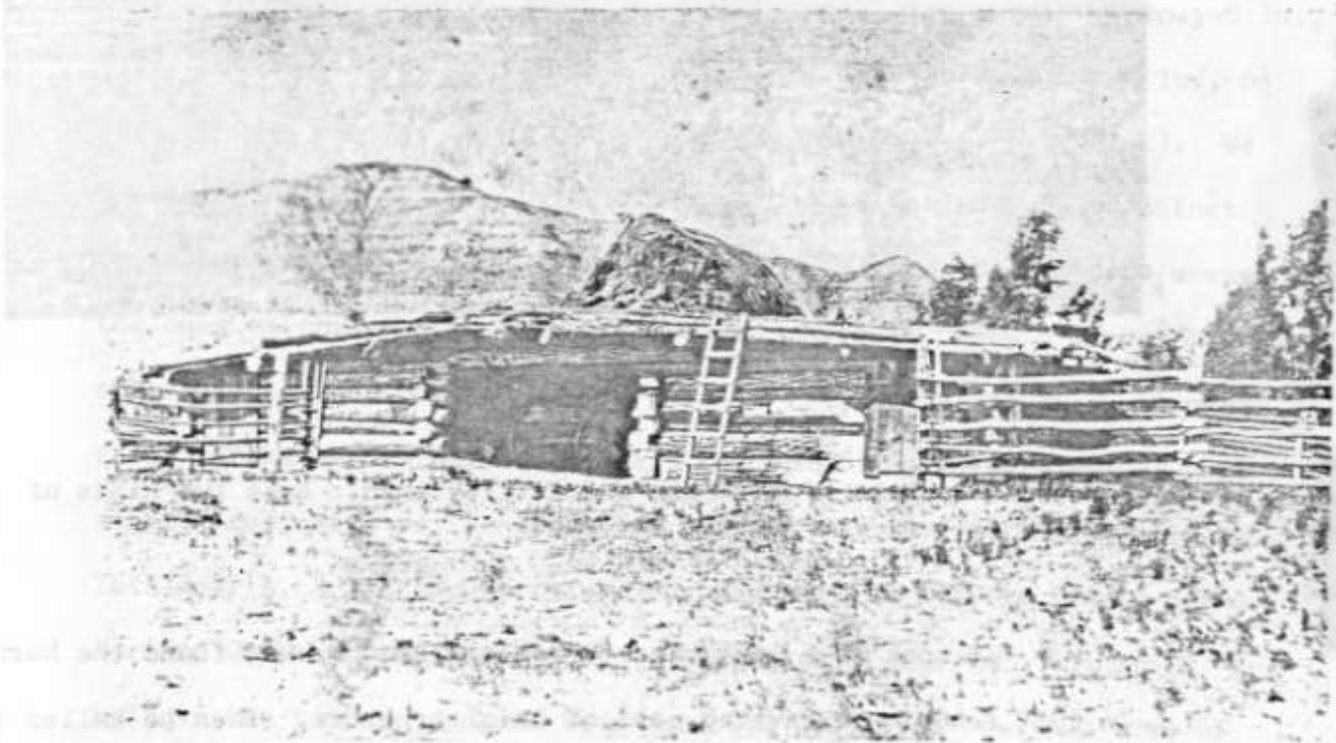
Figure 21.
Roosevelt's close-up view of the barn. Note two stables with space between. Note also the fences.

abutted against the barn. The corrals were arranged so that the west stable door opened into one fenced area and the door of the east stable into another. A window-like opening was cut into the easternmost stable wall (probably in the western one too). In the photograph it looks as though this opening was used to throw manure out from the inside. A close scrutiny of this picture leads me to suggest that there were spaces through the center stable walls where feed could be thrown into the stables from the covered space between.

My sketch, Figure 24, takes some data shown in the photographs, some from archeological excavations, and superimposes them on my map. It is accurate except for possibly two things. We did not find the two centermost fence posts along the front of the barn, and I have tried to envision the locations and function of those posts which Beaubien (NPS Photographs 17011 and 17012) suggested might be part of the west wall. I'm certain that in the west stable the western wall was constructed of horizontally-laid logs. The butt ends show in Figure 21.

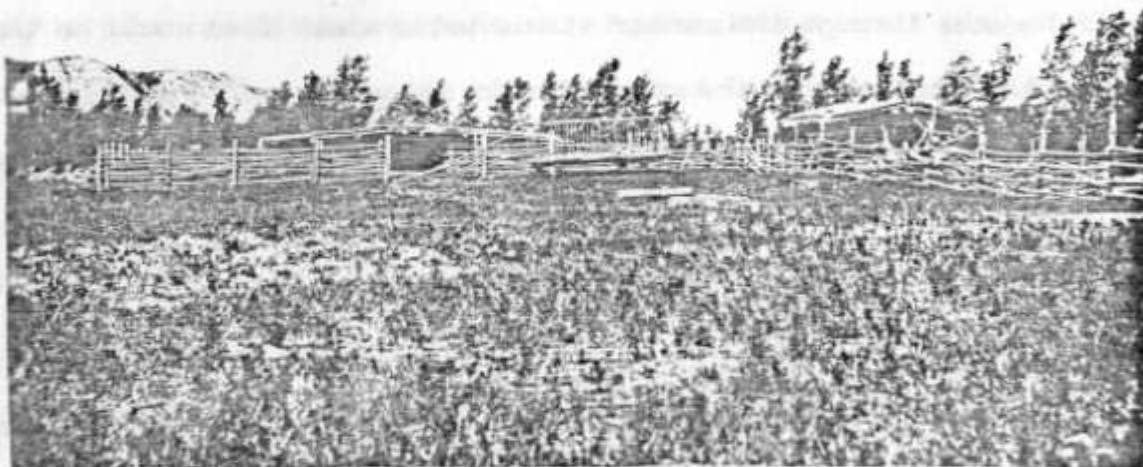
Figure 22.
Roosevelt's photo of the barn and utility shed. Note two kinds of fences, pile of wood before the shed.

shown in Figure 22 and realized that we had the barn. That photograph was taken from a point about 25 feet due west of the well. Roosevelt was looking north. The barn lay about 150 feet northwest of the house (cf. large map).

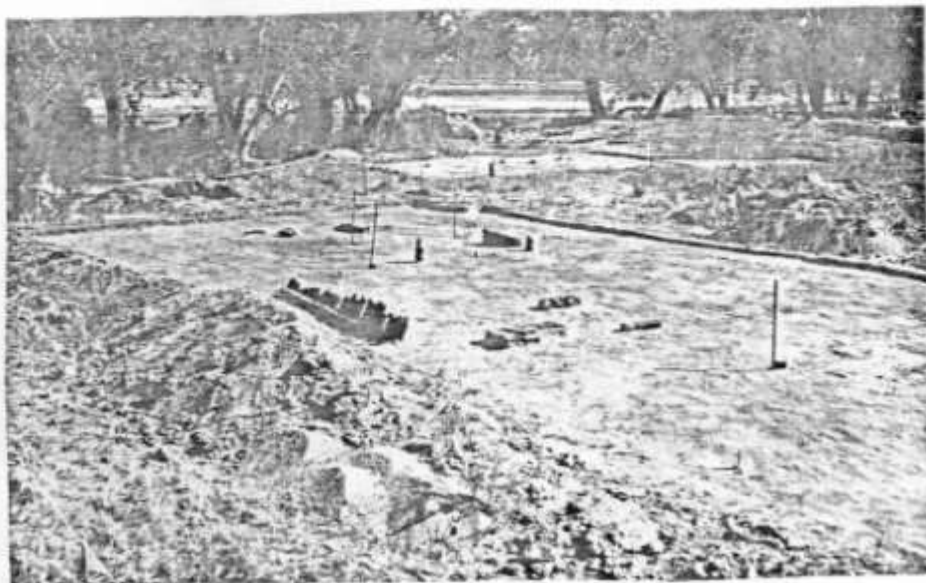
A view of the barn area looking generally in a southeasterly direction. The vertical posts mark the north wall in the space between stables. Beaubien's 1957 excavations were mostly confined to the area west of the eastern stable.

In 1959 we uncovered Beaubien's area and expanded it in all directions, until we were well beyond the area which contained ash and charred wood. We found and mapped the 18 vertical posts in the north wall. (Their diameters, from the west towards east were: $7\frac{1}{4}$ in., 8 in., 7 in., $6\frac{1}{2}$ in., $7\frac{1}{2}$ in., 7 in., $6\frac{1}{4}$ in., $4\frac{3}{4}$ in., $7\frac{1}{4}$ in., $6\frac{3}{4}$ in., $6\frac{1}{2}$ in., 11 in., 11 in., $7\frac{1}{4}$ in., 6 in., $4\frac{3}{4}$ in., 6 in., $5\frac{3}{4}$ in.). We located other posts, and we plotted what seemed to be three distinct but adjacent areas where burning had occurred. In two of these areas, the ones on the east and west, ashes and charcoal, 3 to 4 inches thick, overlay a heavily charred manure level. The manure was $3\frac{1}{2}$ to 4 inches thick in the east stable area, less than that elsewhere. In the east stable area, too, we found charred timbers in baked yellow-colored mud. This debris, $2\frac{3}{4}$ inches thick, overlay ash, some of it finely granular and white (burned hay?), and charcoal nearly an inch thick. I believe the timbers and mud were from the collapsed roof. A view of the entire barn area after we had cleared it is shown in Figure 23.

Fence lines show in our Figures 23, 25, 27, and 28. Our map of the Elkhorn buildings shows the location and arrangement of all

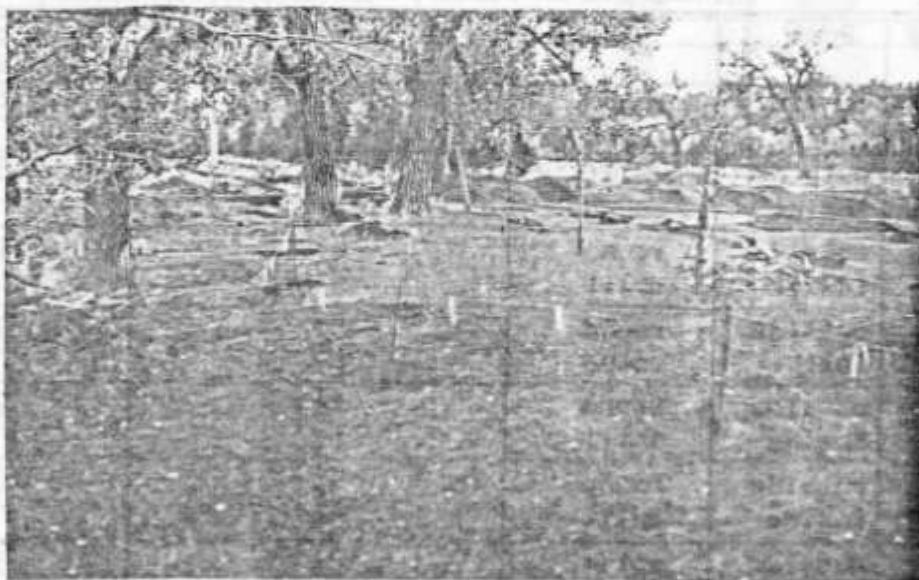
A view showing the fence line east of the ranch house. Vertical slats mark each post; lines are marked by strings with rag streamers. House excavations can be seen on the right.

The house, well, utility shed, and privy were enclosed by a different kind of fence. There single posts were set at 10-foot intervals, and four spaced horizontal bars were nailed to them. This fence circumscribed an asymmetrical area about 110 feet by 100 feet or more long. A portion of this fence line shows along the right-hand side of Roosevelt's photograph (Figure 22). In Figure 2 it is possible to see the fence in front of the house. That same line is shown as we found it in Figure 25. The fence line west of the house joined on to the southern edge of the corral. The fence between the river and house curved towards the northwest, encompassing an area north of the house where the privy was located. The fence probably met the corral again along its eastern side. The fact that several posts were missing obscured our mental picture of that area.

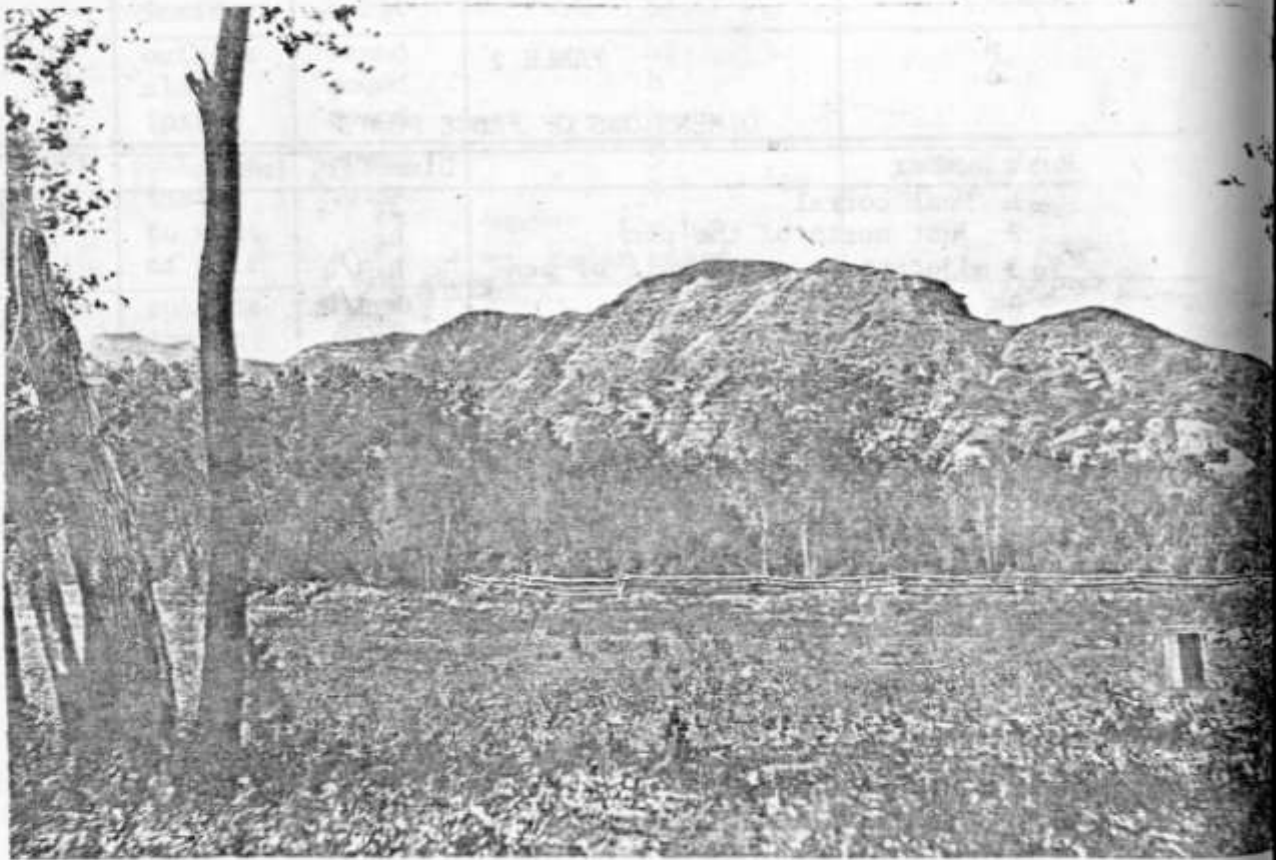
Figure 26.
Roosevelt's photograph of about 1886. The view is looking westward across the clearing. Note fence of "X" frames.

A third kind of fence is shown in one of Roosevelt's photographs (Figure 26). This view looking westward across the Elkhorn clearing, shows a fence along the western edge. This fence line was made of "x" frames set on top of the ground. A horizontal bar spanned the distance between tops of the "x"s, and two other poles were nailed to the frame below. This fence probably served to keep animals out of the gardens as well as keeping ranch animals from drifting off. Because this type of fence rests entirely on the surface we did not expect to find any archeological evidence of its presence.

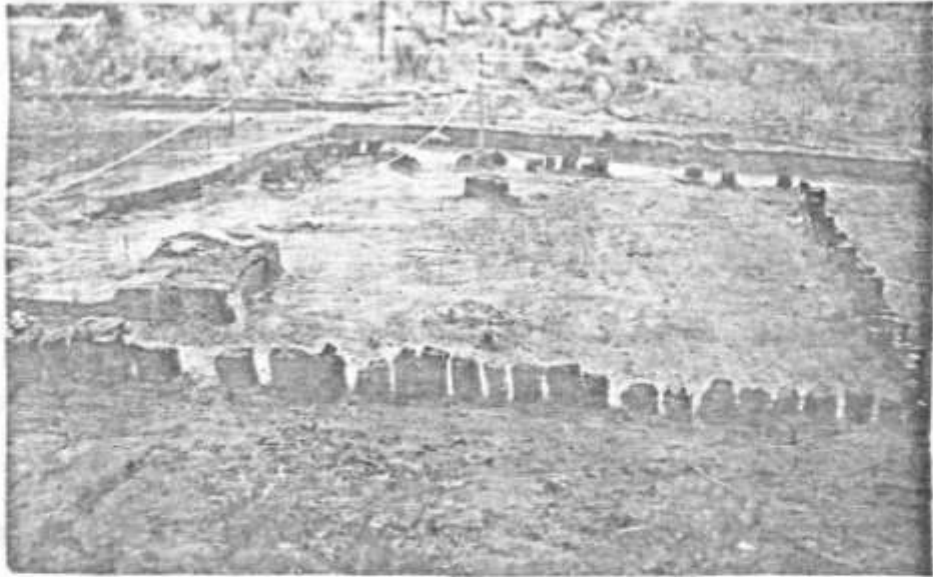
quite a bit of bone within this structure. Perhaps bones were given to hens for them to pick? The pen or chicken coop is shown in Figure 27.

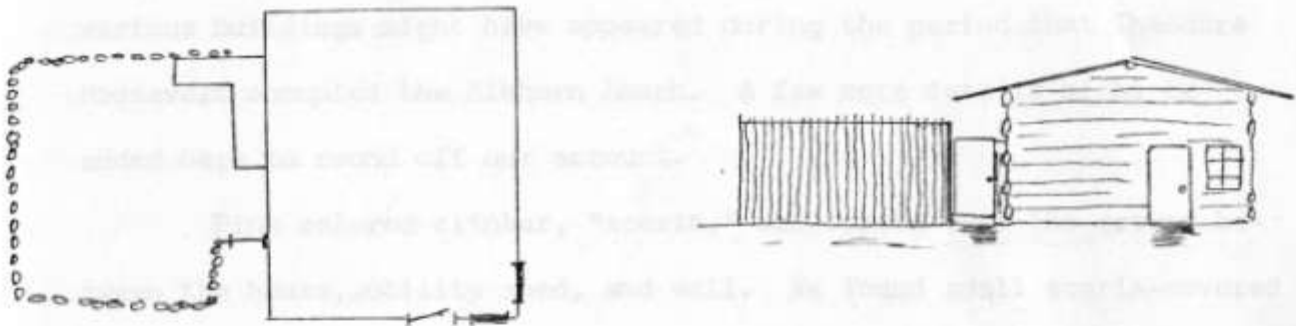
Figure 29.
Sketch of the utility shed and chicken coop.

The chicken coop was built against the west side of the utility shed. Probably this was not a roofed structure, although it could have been. Entry into the coop was likely through a door that hung between the shed and the vertical poles in the east side (see Figure 29). The shed's roof extended out far enough to have covered the entry area. I would think that laying-boxes for hens rested against the wall of the shed. Boards or perhaps a narrow door closed the opening between the shed and the pen wall along the north where there were no posts. The coop could probably keep chickens and poultry inside and most predators out, but Theodore Roosevelt mentions that bobcats successfully got into his hen house time after time (1885, 26).

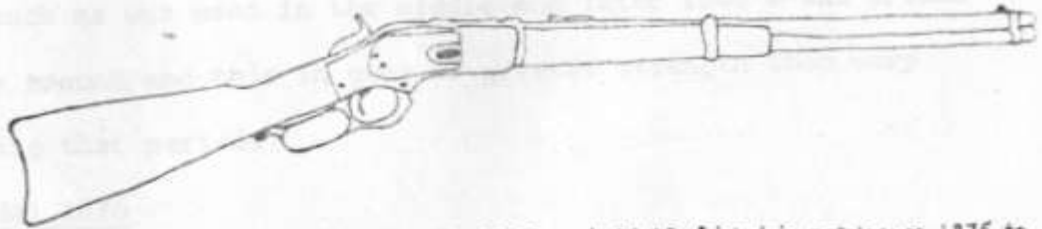
MODEL 1873 CARBINE, calibers .44-40, .38-40 and .32-20. Listed in catalogues 1875 to number 82, 1920.

The Model 73 was built along the lines of the Henry and Model 1866, but was much stronger than its predecessors. The first 73's had a brass frame; and later steel was employed. The Model 1873 was made in the following calibers: .44-40, .38-40, 32-20 and also for the .22 short and long rimfire cartridges. All of the above cartridges are still on the active loading lists, that is, they are still being manufactured in the United States. The .44-40 cartridge was interchangeable between the Model 73 Winchester rifle, and the famous single action Colt revolver. The above cartridges were relatively slow in velocity as well as low in foot-pounds of striking energy. This was due to the relative lack of strength of the Model 73 action as compared to modern rifles. Even with smokeless powder the .44-40 using a 200 grain bullet has a velocity of about 1,310 feet per second and only 760 foot pounds of energy at the muzzle. Shooting at 100 yards the energy drops to only 490 foot pounds. Hence, to hit a target 200 yards away it would be necessary for the bullet to be raised 15 inches; this degree of trajectory is about equivalent to the modern .22 long rifle. The .38-40 and .32-20 were even less powerful, but the .44-40 was adequate for shooting deer at short ranges. In modern rifles the .32-20, with 115 grain jacketed bullet with modern smokeless powder No. 4759, has only a maximum velocity of 1636 feet per second. The .38-40 with 180 grain jacketed bullet with modern smokeless powder No. 4759 has a maximum velocity of only 1765 feet per second in a modern rifle. At this point
